Main Track Derailment

Canadian Pacific Railway
Freight Train Number 235-04
Mile 174.41, Belleville Subdivision
Oshawa, Ontario
05 June 2009

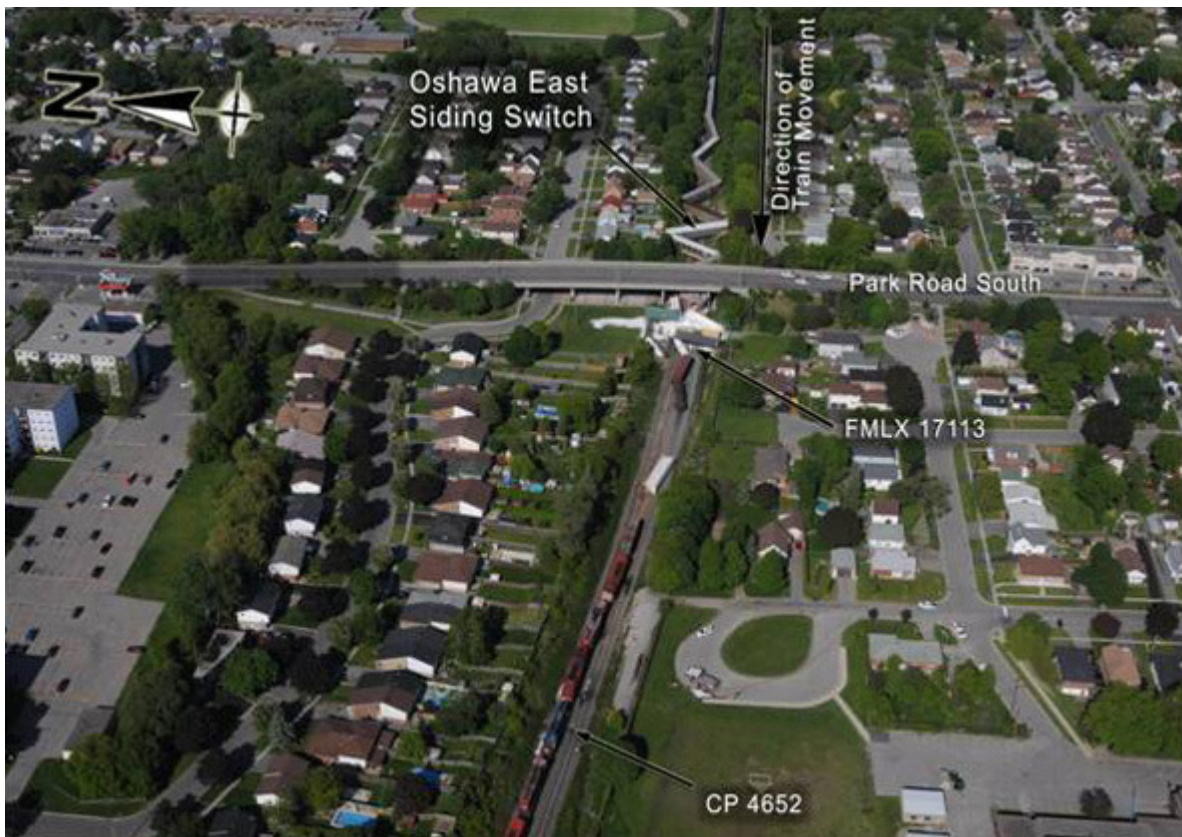
It was determined that the last 4 locomotives and the following 27 cars had derailed. The derailed cars included 7 box cars (3 loaded), 5 covered hopper cars (3 loaded), 7 tank cars (6 loaded) and 8 empty multi-level, flat cars (see [Photo 1](#)). One of the derailed cars, dangerous goods (DG) tank car FMLX 17113, was loaded with hydrogen peroxide (UN 2015). The car remained intact and no product was released; however, about 3000 gallons of diesel fuel spilled from damaged locomotive fuel tanks into adjacent ditches and ignited. Emergency responders were dispatched, extinguished the fires and contained the spilled diesel fuel. As a precaution, 105 nearby homes were evacuated. The evacuation order remained in effect until noon the next day, when FMLX 17113 was secured and removed. There were no injuries.

Photo 1. Aerial view of derailment

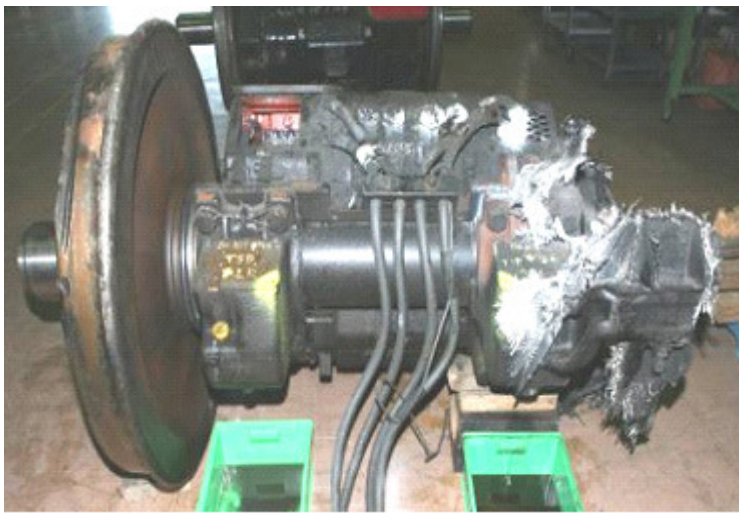
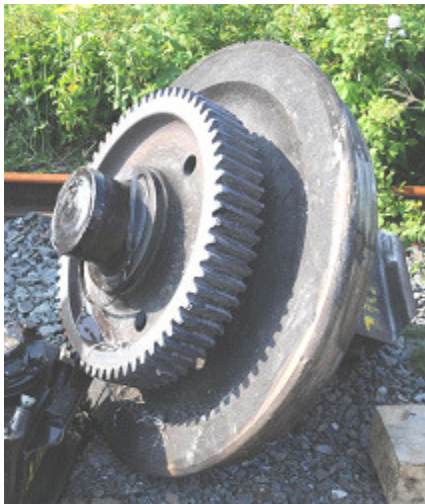
Photo 2. Left: CP 4652 No.1 TM combo

Right: Broken axle with bull gear

The axle from TM combo No. 1 fractured near the midpoint of the gear side suspension bearing area. The pinion gear had been stripped of its teeth and the mate bull gear was void of lubricant

and exhibited minor teeth damage. The fractured stub end of the failed axle (bull gear side) showed extensive smearing damage consistent with continued operation after failure. Due to overheating, oil levels were lower on the gear side and the wick had completely disintegrated. However, the operation and alignment of the wick relative to the suspension bearing window appeared normal. On the side opposite the bull gear (commutator side), the wick was properly aligned and in good operating condition.

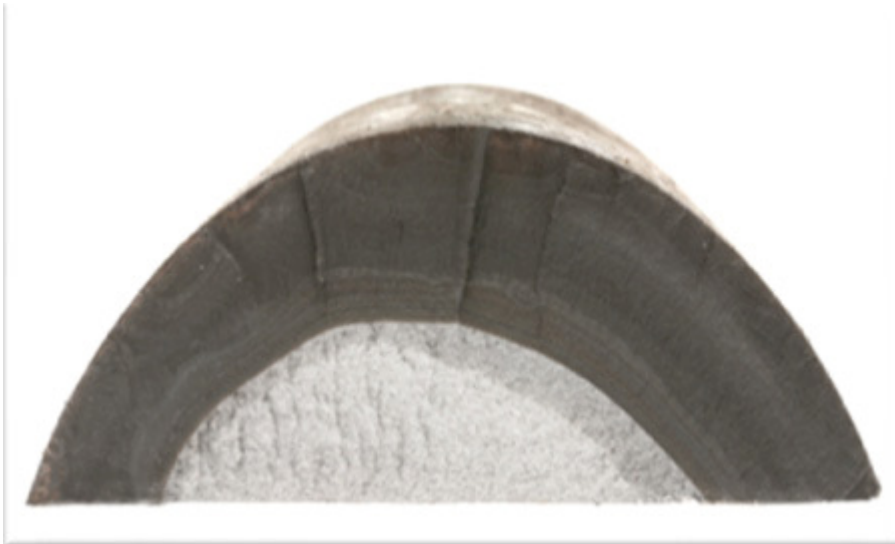
The axle from TM combo No. 3 was not fractured through. The bull gear cover was damaged and the bull gear teeth were shiny and dry. The gear-side bearing components were heat discoloured. The bull gear was devoid of lubricant and the gear case was damaged. The wicks appeared to be properly aligned.

Ultrasonic inspection revealed 3 secondary cracks inboard of and parallel to the primary fracture on the axle of combo No. 1. The axle from combo No. 3 had 1.5 inch deep radial cracks around its entire circumference at the approximate center of the gear side suspension bearing area ([Photo 4](#)).

Photo 4. Close-up of secondary crack in axle No. 3

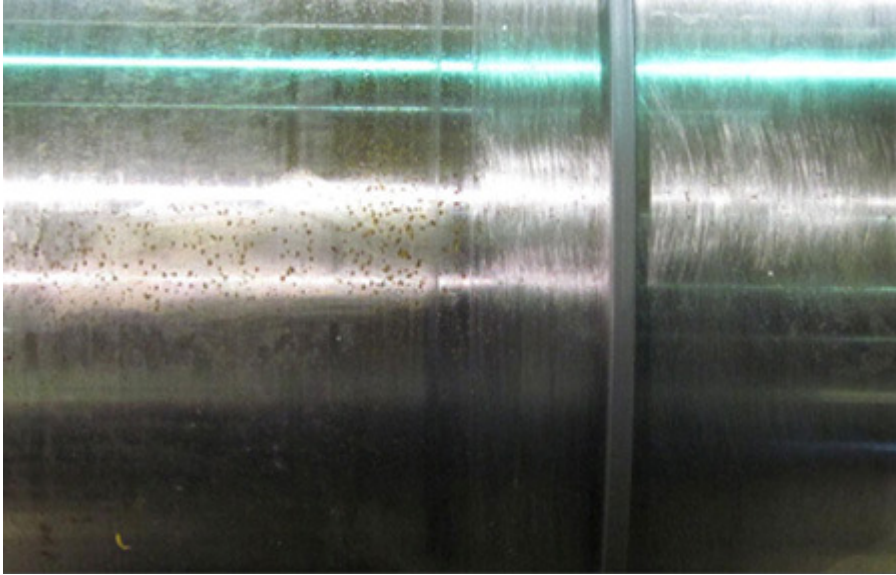
Surface roughness in the axle suspension bearing journal area on axles 1, 2 and 3 from CP 4652 ranged from 14 to 22 micro-inches. Each axle journal exhibited corrosion pits and a significant number of multi-directional scratches consistent with mechanical damage from the use of abrasive paper. The scratches varied in orientation and depth (see [Photo 5](#)). The axle from CP 3024 had similar surface features and roughness.

Photo 5. Axle 2 from CP 4652
