Main Track Derailment

Canadian Pacific Railway
Freight Train Number 235-04
Mile 174.41, Belleville Subdivision
Oshawa, Ontario
05 June 2009

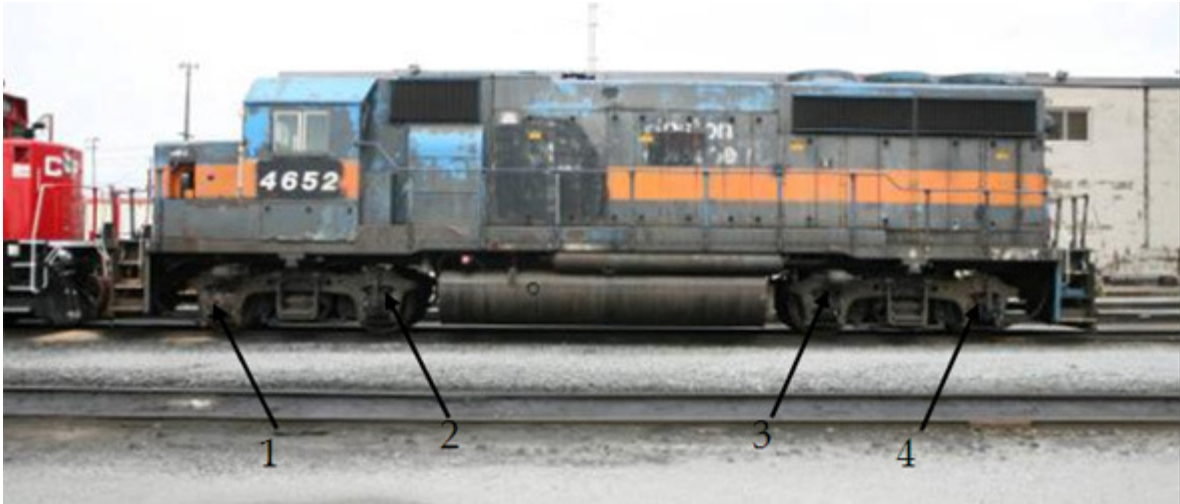
Photo 3. Left side view of CP 4652 showing traction motor assembly position numbering

CP 4652 (see [Photo 3](#)) is a 3000 horsepower, 4-axle GP40-2 locomotive built in 1977 by General Motors (GM) Electro-Motive Division. It is 1 of 665 locomotives in CP's fleet that operate with TMs equipped with plain friction-type brass and babbitt suspension bearings (suspension bearings). The 665 locomotives represent approximately 53% of CP's total locomotive fleet of 1250 units. On-board suspension bearing temperature monitoring systems are available for these locomotives; however, none of these CP locomotives are so equipped.

The last scheduled service for CP 4652 was performed at CP's Toronto Diesel Shop (TDS) on 03 May 2009. No major repairs were performed. The required wheel inspection form was partially completed with only the wheel tread thickness recorded.

CP 4652 returned for unscheduled service on 16 May 2009 for a thin flange on the No. 4 TM assembly wheel set, a burnt out headlight, missing weather stripping and a bouncy ride. The No. 4 TM wheel set had been replaced with a dummy wheel set for transit; the corresponding TM cut-out switch in the locomotive cab was locked out and tagged.

Repair work on CP 4652 began on 19 May 2009. During the repairs, several additional defects were identified and all 4 TM combos were scheduled for change out. Over the following 2 days, subsequent shifts removed and replaced the 4 combos. TM combos Nos. 1, 2 and 3 were replaced with combos built up at the TDS on 23 and 24 February 2009 and on 26 March 2009, respectively. The No. 4 TM combo was taken from another locomotive that was being serviced.

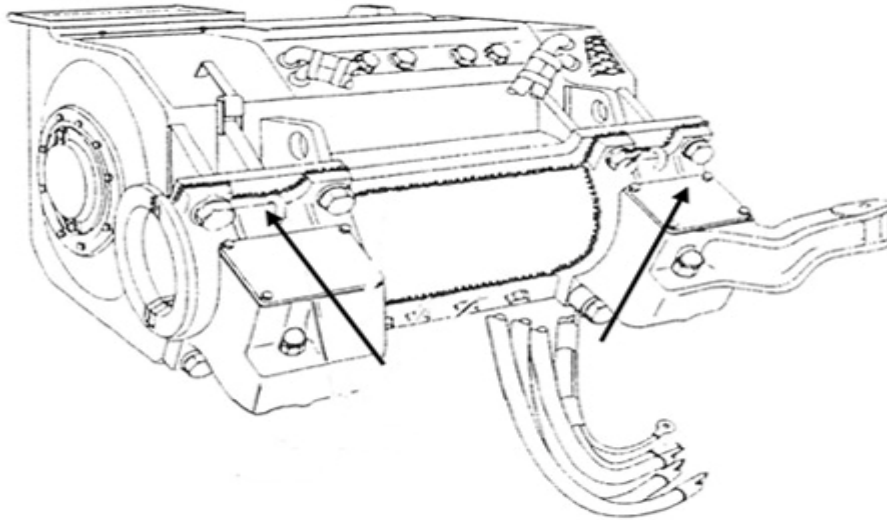
Figure 3. Traction motor (the arrows point to the location of the suspension bearings)

TMs are suspended from locomotive axles on bearings located on each side of a TM (see [Figure 3](#)). The suspension bearings allow the free rotation of the axle while TM torque is applied to the locomotive wheel set through a pinion gear to a bull gear which is press mounted on the axle, inboard of a wheel. The gear side of the axle has historically proven to be more susceptible to failure primarily due to the torque focussed at that location.

A thin film of oil provides lubrication between the finely machined surface of the locomotive axle journal and the inner surface of the suspension bearing. The inner surface of the brass suspension bearing is lined with babbitt metal. Babbitt metal is an anti-friction alloy lining for brass bearings; it is composed primarily of lead, with various amounts of tin, antimony and copper. The babbitt provides a load bearing surface and facilitates lubrication. While the train is in motion, oil is constantly applied to the axle journal surface through the capillary action of a wick that contacts the journal surface and extends down into the oil reservoir located in the axle cap.

There is a large quantity of accumulated research that identifies a failure mechanism, known as liquid metal embrittlement (LME), which can occur in axle steel when used with plain-type suspension bearings. LME occurs when the ductility of a solid metal is reduced by exposure of the surface to a liquid metal. The loss of ductility results in a reduction in the axle toughness. Toughness is the property that gives a material its resistance to crack initiation and propagation. The progression of LME usually occurs in the following sequence:
